Manhole Inspection Summary

Manhole # S170__003MH

Location Address: **421 millington ave**

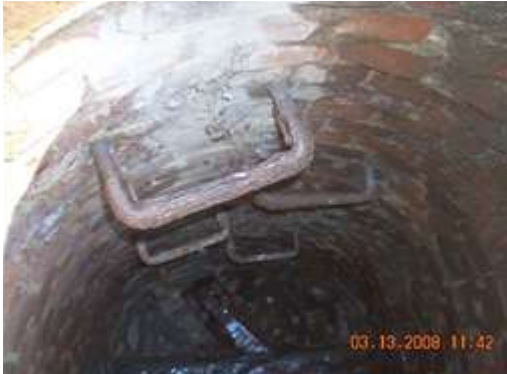
Defect 2

Count: **5** Missing: **0** ☒ **Corroded**

corroded steps

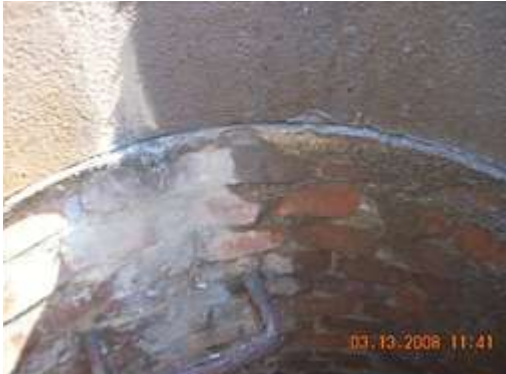
Defect 1

Infiltration: ☐ None ☒ **Joint** ☐ Cracks ☐ Mortar ☐ Roots ☐ Wall

evidence of inflo

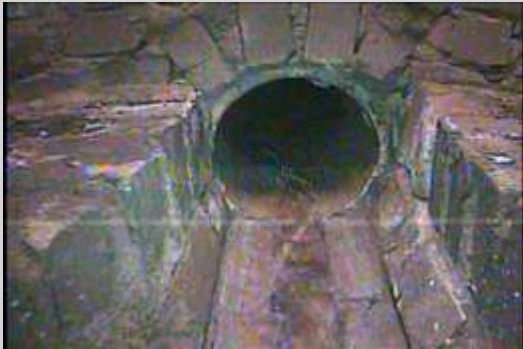
12 O'Clock Outflow

Pipe Height: **8.4** (in.) Rod and Bar (Angled)
Pipe Material: **Clay** ☐ Pipe Lined
Invert Depth: **9.51** (ft.) Flow Characteristics: **Slow**
Deposits: ☒ None ☐ Mud ☐ Sludge ☐ Debris ☐ Grease
Silt Depth: **0** (in.) Deposits Extent:
Infiltration: **None** Pipe Seal Cond: **Sound**

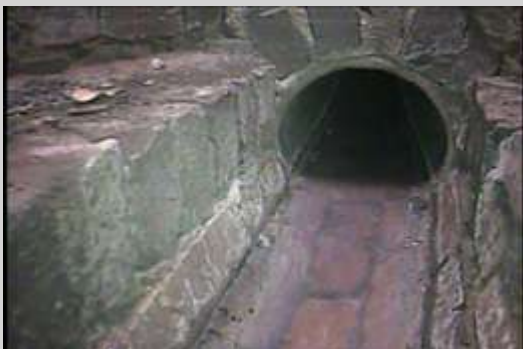
6 O'Clock Inflow

Pipe Height: **8.4** (in.) Rod and Bar (Angled)
Pipe Material: **Clay** ☐ Pipe Lined
Invert Depth: **9.36** (ft.) Flow Characteristics: **Slow**
Deposits: ☒ None ☐ Mud ☐ Sludge ☐ Debris ☐ Grease
Silt Depth: **0** (in.) Deposits Extent:
Infiltration: **None** Pipe Seal Cond: **Sound**

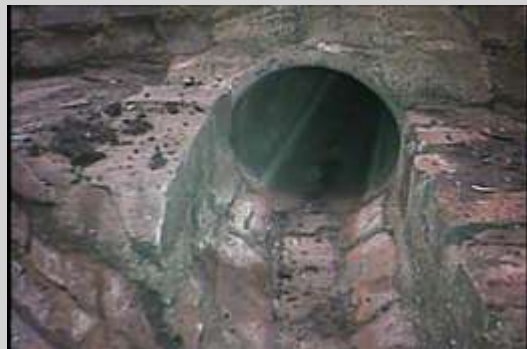
8 O'Clock Inflow

Infiltration: **None** Pipe Seal Cond: **Sound**

Connects To: **Dead End**
